# WEFIX4U DEFECT SUPPORT REPORT

## SAMPLE REPORT - FOR ILLUSTRATION ONLY

| Specific Defect Item | Ceiling finish detachment / loose overhead material |

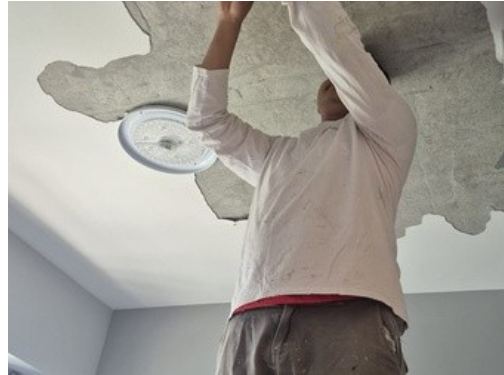
### Photograph A1

| 1 | A significant section of ceiling finishing material had detached, leaving the underlying ceiling surface visibly exposed. |
| 4 | The affected boundary indicated loss of adhesion between applied finishing material and the underlying ceiling surface. |

#### Affected Ceiling Area

The photograph shows a section of ceiling where finishing material has detached, exposing the underlying ceiling surface. The image provides visual context for the extent and location of the observed condition.

| 2 | Arrange further assessment by the management-appointed contractor, building consultant or other appropriate specialist. |
| 3 | Check whether additional loose or weakly bonded material exists beyond the visibly affected area and identify the underlying cause before permanent rectification. |

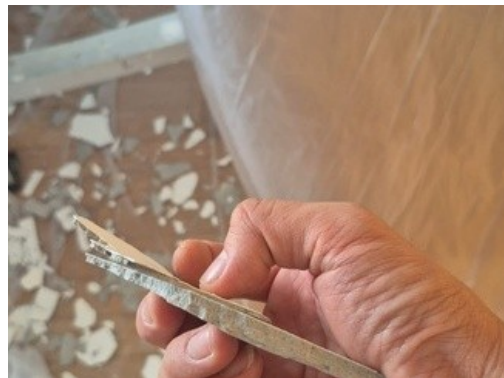
### Photograph A2

| 2 | The detached material appeared to comprise multiple finishing layers, including paint coating, skim coat and plastering material. |
| 3 | The condition extended beyond isolated surface paint peeling and showed noticeable thickness and layered composition. |

#### Detached Ceiling Material

The photograph shows a sample of detached ceiling material removed from the affected area. The visible thickness and layered composition support the observation that the condition extends beyond superficial paint peeling.
